# Home Report

30 KINGSBARNES DRIVE  
GLASGOW  
G44 4SL

# Energy Performance Certificate (EPC)

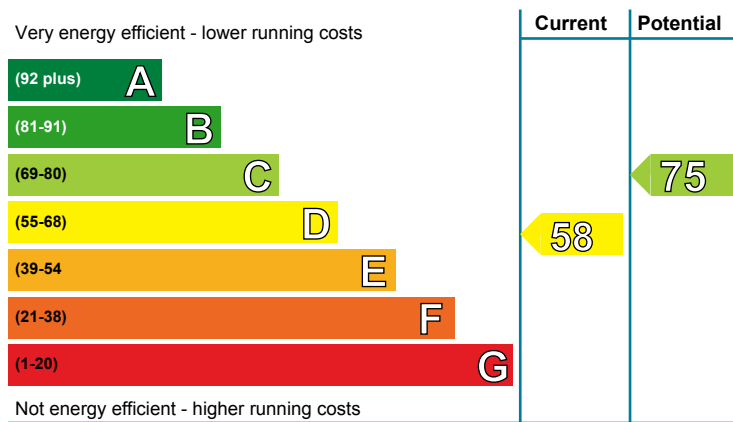
## Energy Efficiency Rating

This graph shows the current efficiency of your home, taking into account both energy efficiency and fuel costs. The higher this rating, the lower your fuel bills are likely to be.

Your current rating is **band D (58)**. The average rating for EPCs in Scotland is **band D (61)**.

The potential rating shows the effect of undertaking all of the improvement measures listed within your recommendations report.

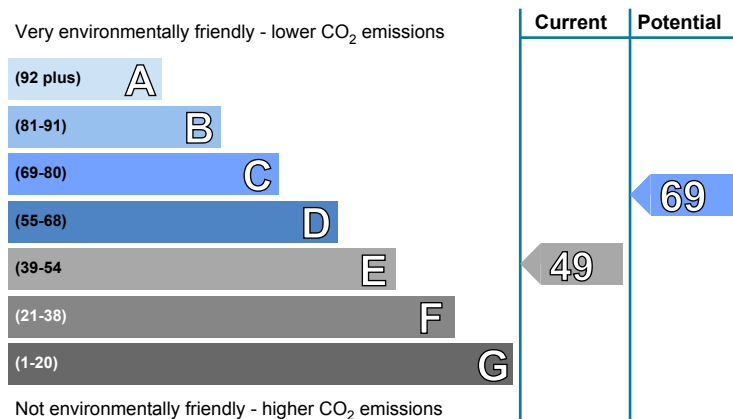
## Environmental Impact (CO<sub>2</sub>) Rating

This graph shows the effect of your home on the environment in terms of carbon dioxide (CO<sub>2</sub>) emissions. The higher the rating, the less impact it has on the environment.

Your current rating is **band E (49)**. The average rating for EPCs in Scotland is **band D (59)**.

The potential rating shows the effect of undertaking all of the improvement measures listed within your recommendations report.
