**Walker Fraser Steele**  
**Chartered Surveyors**

FLAT 3/3  
1103 CATHCART ROAD  
GLASGOW  
G42 9XP

## Energy Performance Certificate

FLAT 3/3, 1103 CATHCART ROAD, GLASGOW, G42 9XP

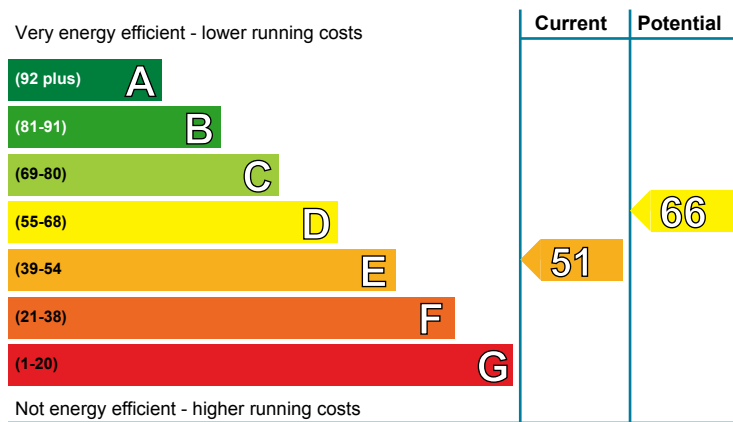
## Energy Efficiency Rating

This graph shows the current efficiency of your home, taking into account both energy efficiency and fuel costs. The higher this rating, the lower your fuel bills are likely to be.

Your current rating is **band E (51)**. The average rating for EPCs in Scotland is **band D (61)**.

The potential rating shows the effect of undertaking all of the improvement measures listed within your recommendations report.

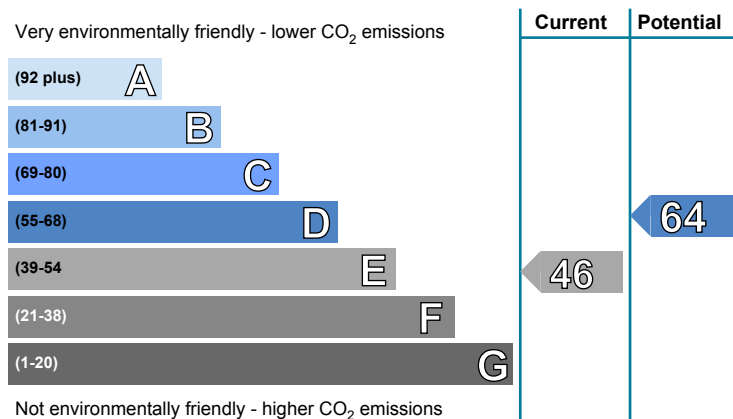
## Environmental Impact (CO<sub>2</sub>) Rating

This graph shows the effect of your home on the environment in terms of carbon dioxide (CO<sub>2</sub>) emissions. The higher the rating, the less impact it has on the environment.

Your current rating is **band E (46)**. The average rating for EPCs in Scotland is **band D (59)**.

The potential rating shows the effect of undertaking all of the improvement measures listed within your recommendations report.
