Walker Fraser Steele
Chartered Surveyors

FLAT 3/2
17 SOMERVILLE DRIVE
GLASGOW
G42 9BE

Energy Performance Certificate

FLAT 3/2, 17 SOMERVILLE DRIVE, GLASGOW, G42 9BE

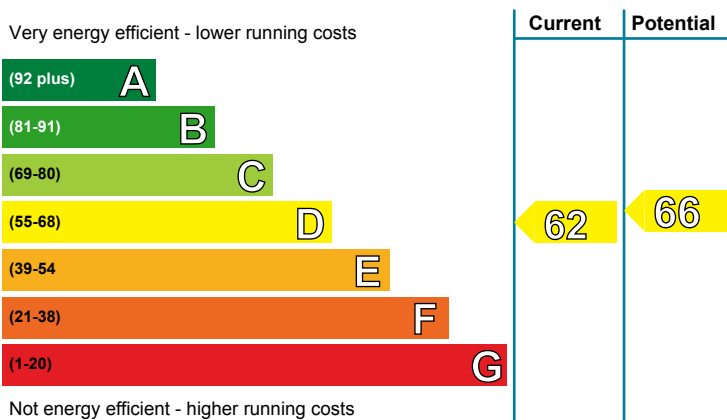
Energy Efficiency Rating

This graph shows the current efficiency of your home, taking into account both energy efficiency and fuel costs. The higher this rating, the lower your fuel bills are likely to be.

Your current rating is **band D (62)**. The average rating for EPCs in Scotland is **band D (61)**.

The potential rating shows the effect of undertaking all of the improvement measures listed within your recommendations report.
