Walker Fraser Steele
Chartered Surveyors

66 SPRINGHILL ROAD
GLASGOW
G69 6NT

Energy Performance Certificate

Dwelling type: End-terrace house
Date of assessment: 29 June 2023
Date of certificate: 29 June 2023
Total floor area: 139 m²
Primary Energy Indicator: 172 kWh/m²/year

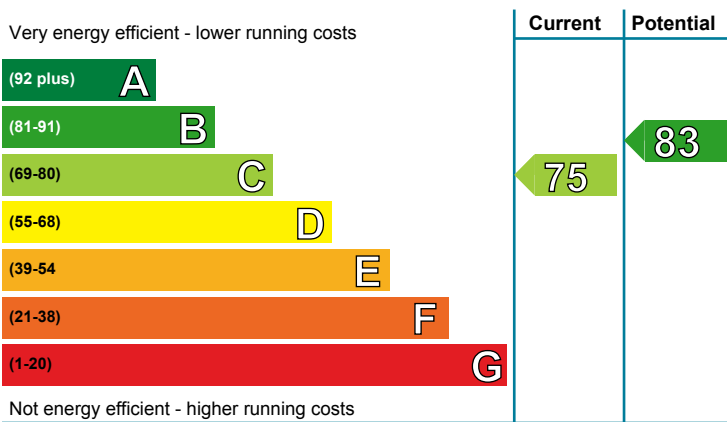
Energy Efficiency Rating

This graph shows the current efficiency of your home, taking into account both energy efficiency and fuel costs. The higher this rating, the lower your fuel bills are likely to be.

Your current rating is **band C (75)**. The average rating for EPCs in Scotland is **band D (61)**.

The potential rating shows the effect of undertaking all of the improvement measures listed within your recommendations report.
