Energy Performance Certificate

1B Westbourne Gardens, Hyndland, Glasgow, G12 9XA

Dwelling type:	Ground-floor flat
Date of assessment:	10 August 2023
Date of certificate:	20 August 2023
Total floor area:	101 m ²
Primary Energy Indicator:	221 kWh/m ² /year

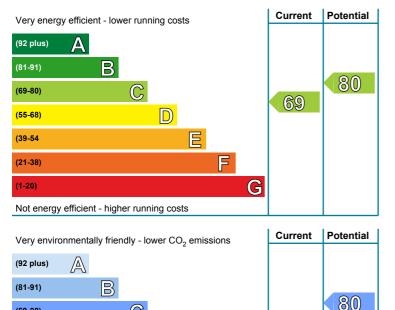
Energy Efficiency Rating

This graph shows the current efficiency of your home, taking into account both energy efficiency and fuel costs. The higher this rating, the lower your fuel bills are likely to be.

Your current rating is band C (69). The average rating for EPCs in Scotland is band D (61).

The potential rating shows the effect of undertaking all of the improvement measures listed within your recommendations report.
