FLAT 2/2
1065 CATHCART ROAD
GLASGOW
G42 9AF

Energy Performance Certificate

FLAT 2/2, 1065 CATHCART ROAD, GLASGOW, G42 9AF

Dwelling type: Mid-floor flat
Date of assessment: 07 November 2023
Date of certificate: 07 November 2023
Total floor area: 43 m²
Primary Energy Indicator: 242 kWh/m²/year

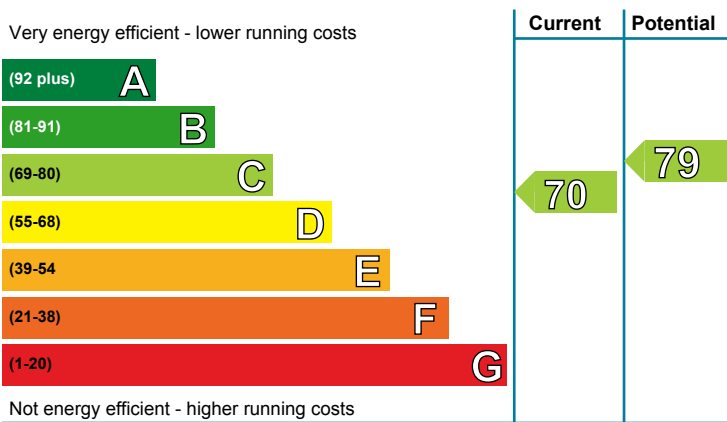
Energy Efficiency Rating

This graph shows the current efficiency of your home, taking into account both energy efficiency and fuel costs. The higher this rating, the lower your fuel bills are likely to be.

Your current rating is **band C (70)**. The average rating for EPCs in Scotland is **band D (61)**.

The potential rating shows the effect of undertaking all of the improvement measures listed within your recommendations report.

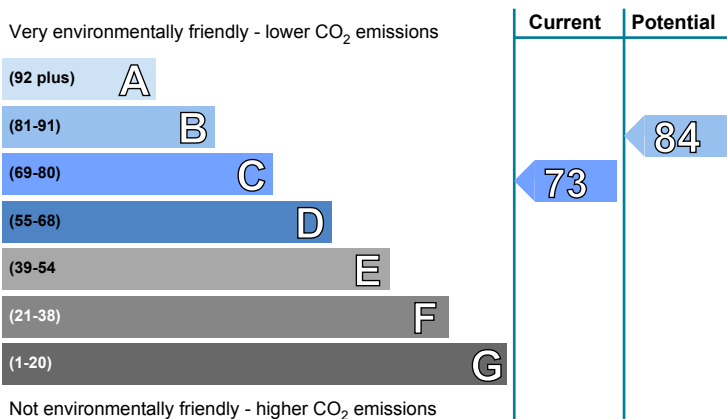
Environmental Impact (CO₂) Rating

This graph shows the effect of your home on the environment in terms of carbon dioxide (CO₂) emissions. The higher the rating, the less impact it has on the environment.

Your current rating is **band C (73)**. The average rating for EPCs in Scotland is **band D (59)**.

The potential rating shows the effect of undertaking all of the improvement measures listed within your recommendations report.
