# Walker Fraser Steele Chartered Surveyors

Flat 0/2  
346 Langside Road  
Glasgow  
G42 8XR

## Energy Performance Certificate

Flat 0/2, 346 Langside Road, Glasgow, G42 8XR

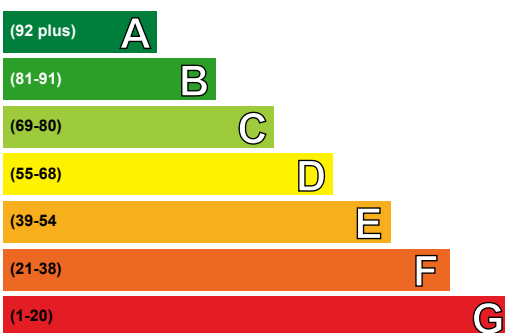
## Energy Efficiency Rating

This graph shows the current efficiency of your home, taking into account both energy efficiency and fuel costs. The higher this rating, the lower your fuel bills are likely to be.

Your current rating is **band D (62)**. The average rating for EPCs in Scotland is **band D (61)**.

The potential rating shows the effect of undertaking all of the improvement measures listed within your recommendations report.
