Home Report

Single Survey

Property Address	57 Captains Road Edinburgh City of Edinburgh EH17 8HP
Customer	Executory of Mr Peter Fraser
Date of Inspection	15/04/2026
Prepared by	Stephen Phillips Walker Fraser Steele

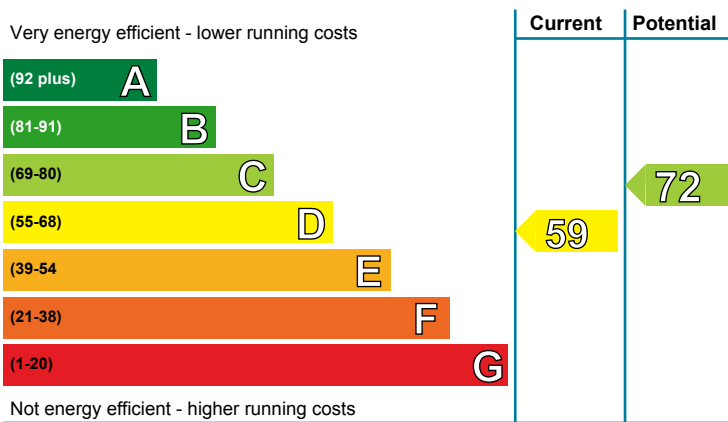
Energy Efficiency Rating

This graph shows the current efficiency of your home, taking into account both energy efficiency and fuel costs. The higher this rating, the lower your fuel bills are likely to be.

Your current rating is **band D (59)**. The average rating for EPCs in Scotland is **band D (61)**.

The potential rating shows the effect of undertaking all of the improvement measures listed within your recommendations report.

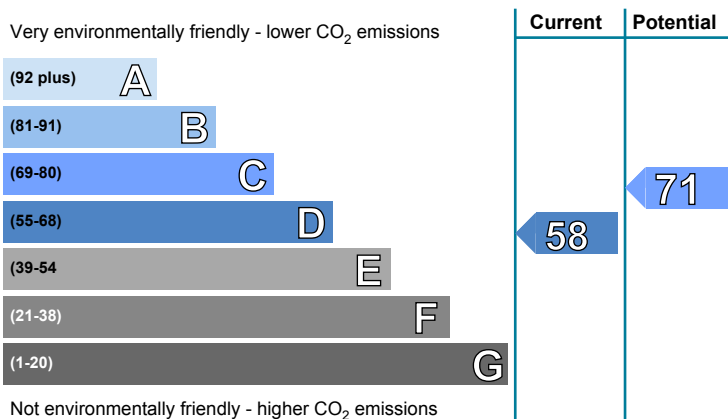
Environmental Impact (CO₂) Rating

This graph shows the effect of your home on the environment in terms of carbon dioxide (CO₂) emissions. The higher the rating, the less impact it has on the environment.
