Home Report

FLAT 0/1
19 MEIKLE ROAD
GLASGOW
G53 5JG

**Walker Fraser Steele
Chartered Surveyors**

Energy Performance Certificate (EPC)

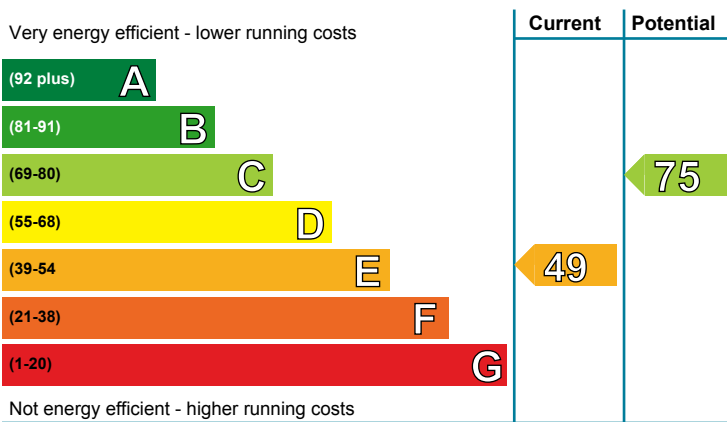
Energy Efficiency Rating

This graph shows the current efficiency of your home, taking into account both energy efficiency and fuel costs. The higher this rating, the lower your fuel bills are likely to be.

Your current rating is **band E (49)**. The average rating for EPCs in Scotland is **band D (61)**.

The potential rating shows the effect of undertaking all of the improvement measures listed within your recommendations report.
